### REHABILITATE FACADE

### STATE INSURANCE FUND HEADQUARTERS 199 CHURCH STREET, NEW YORK, NY 10007 O.G.S. PROJECT NO. 45143-C

SUPERSTRUCTURE PLAN

S-100

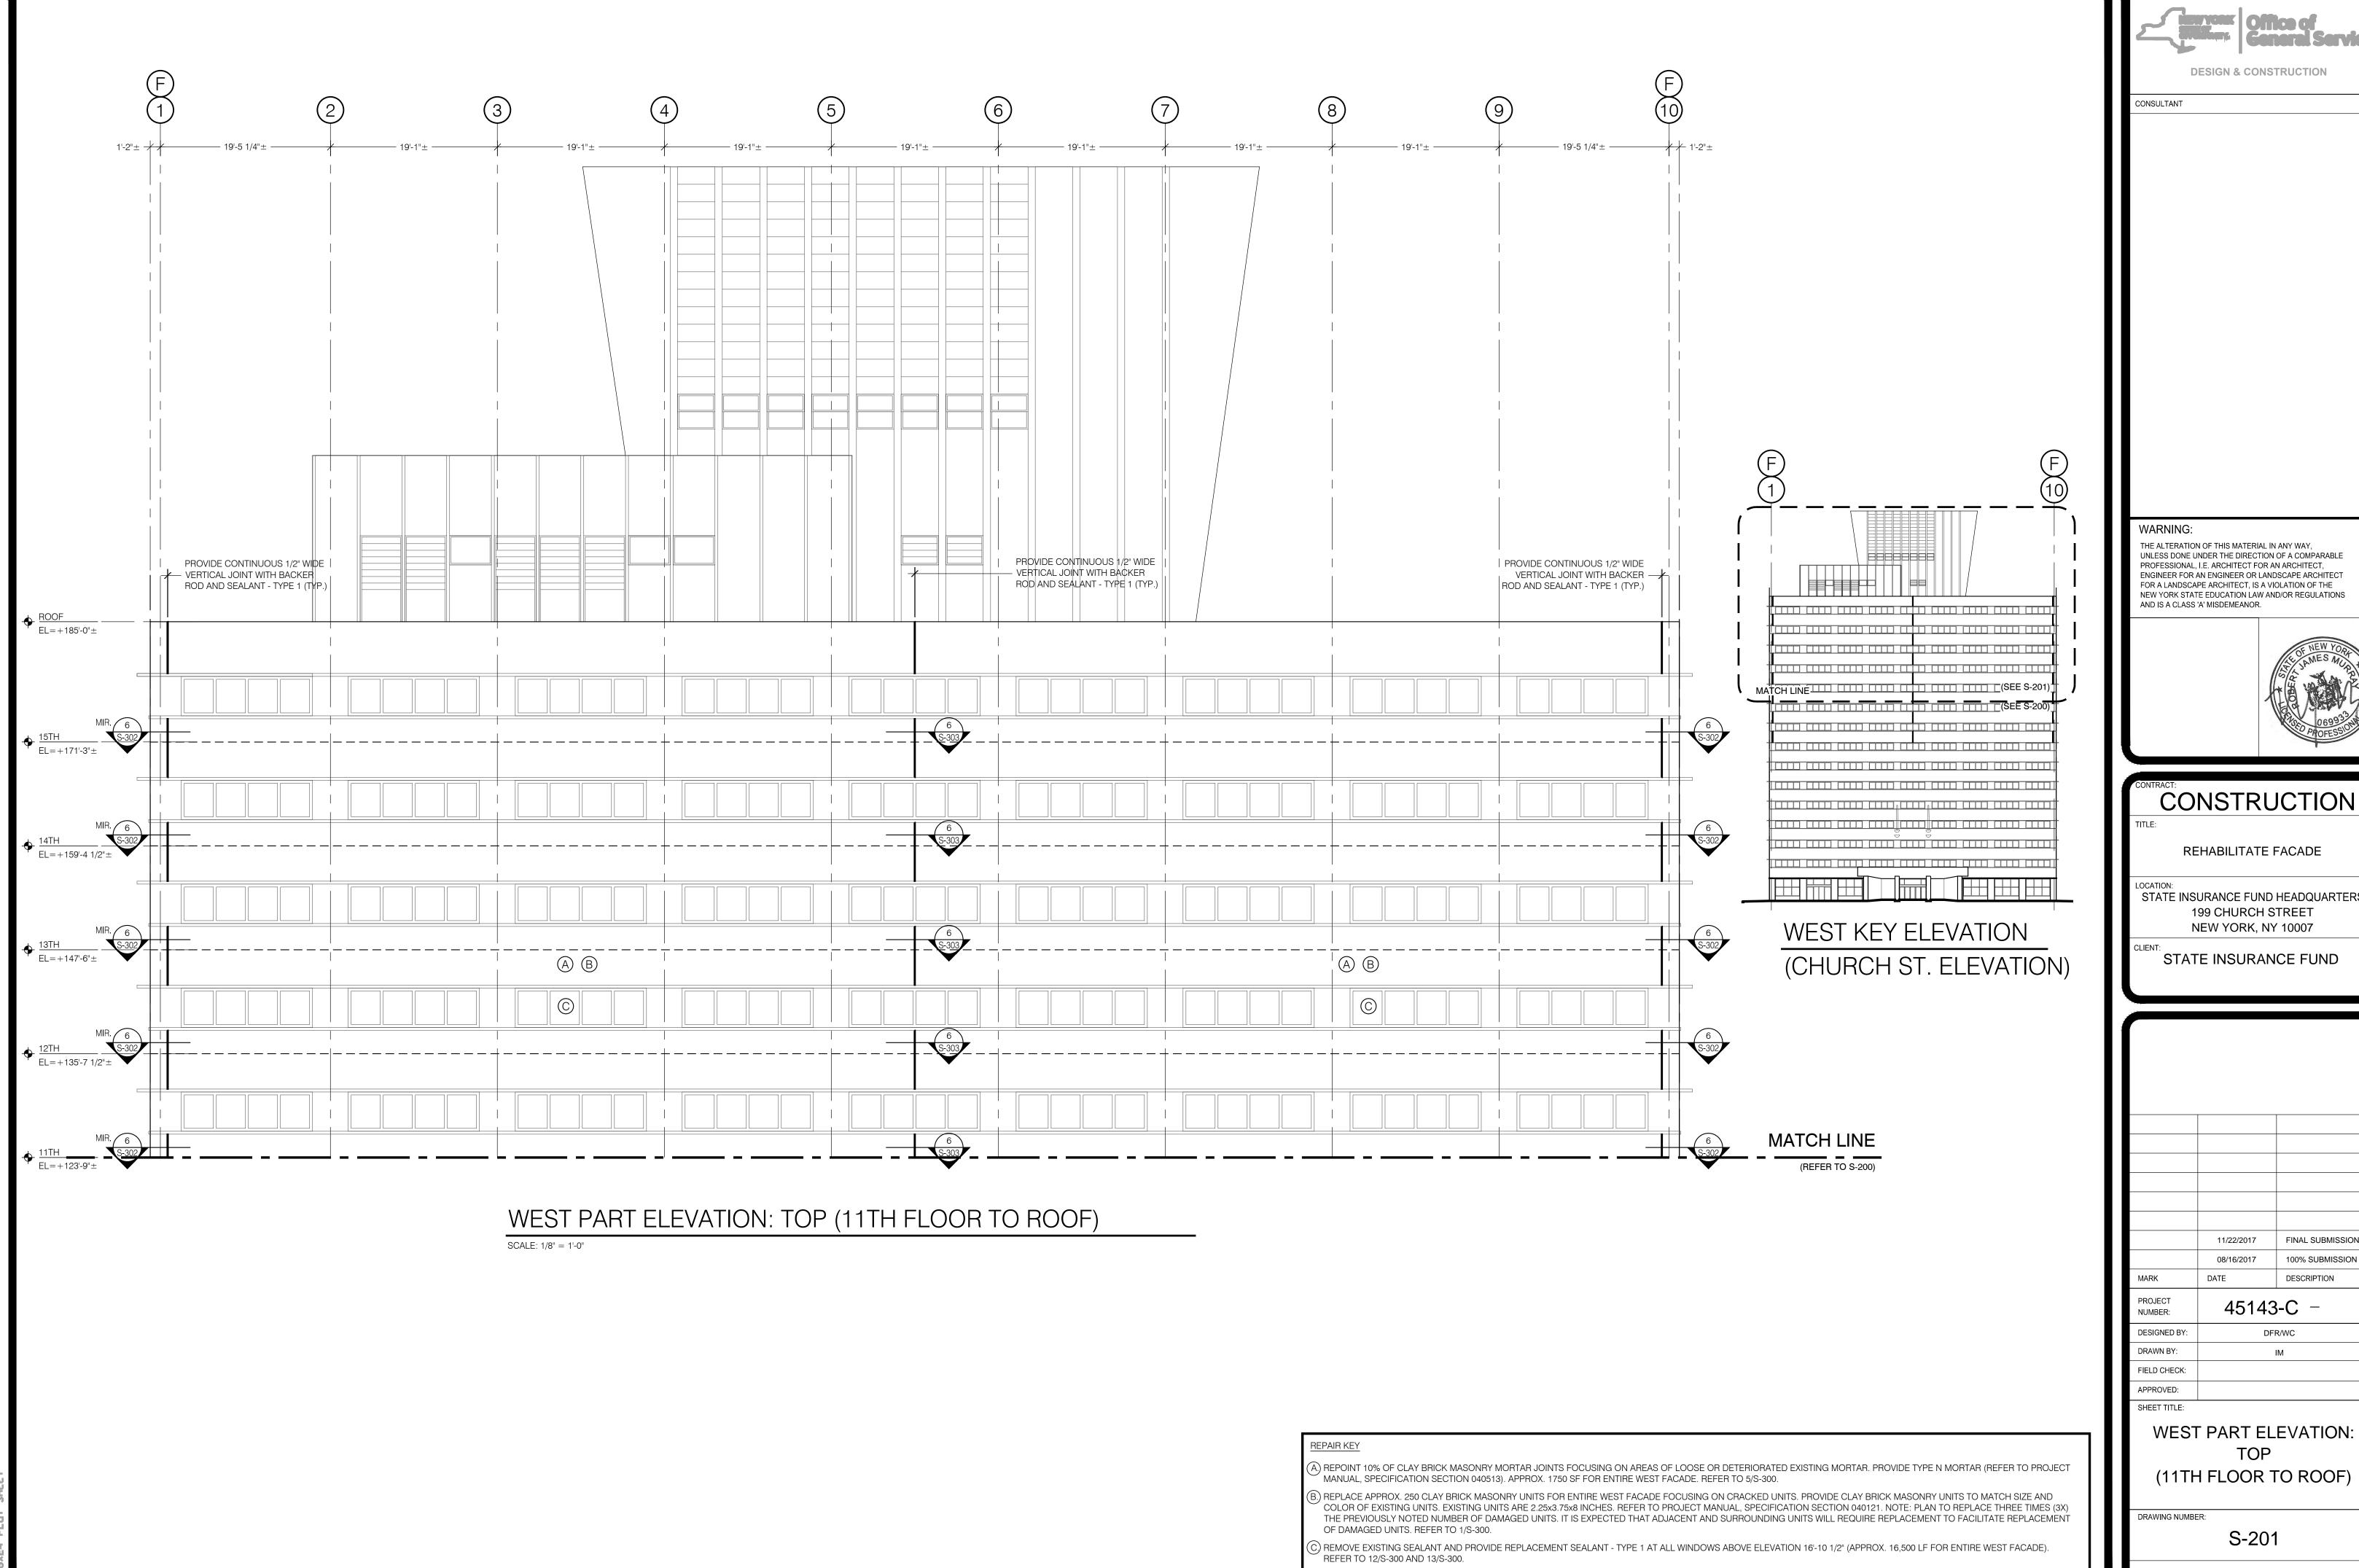
WEST PART ELEVATION:

(11TH FLOOR TO ROOF)

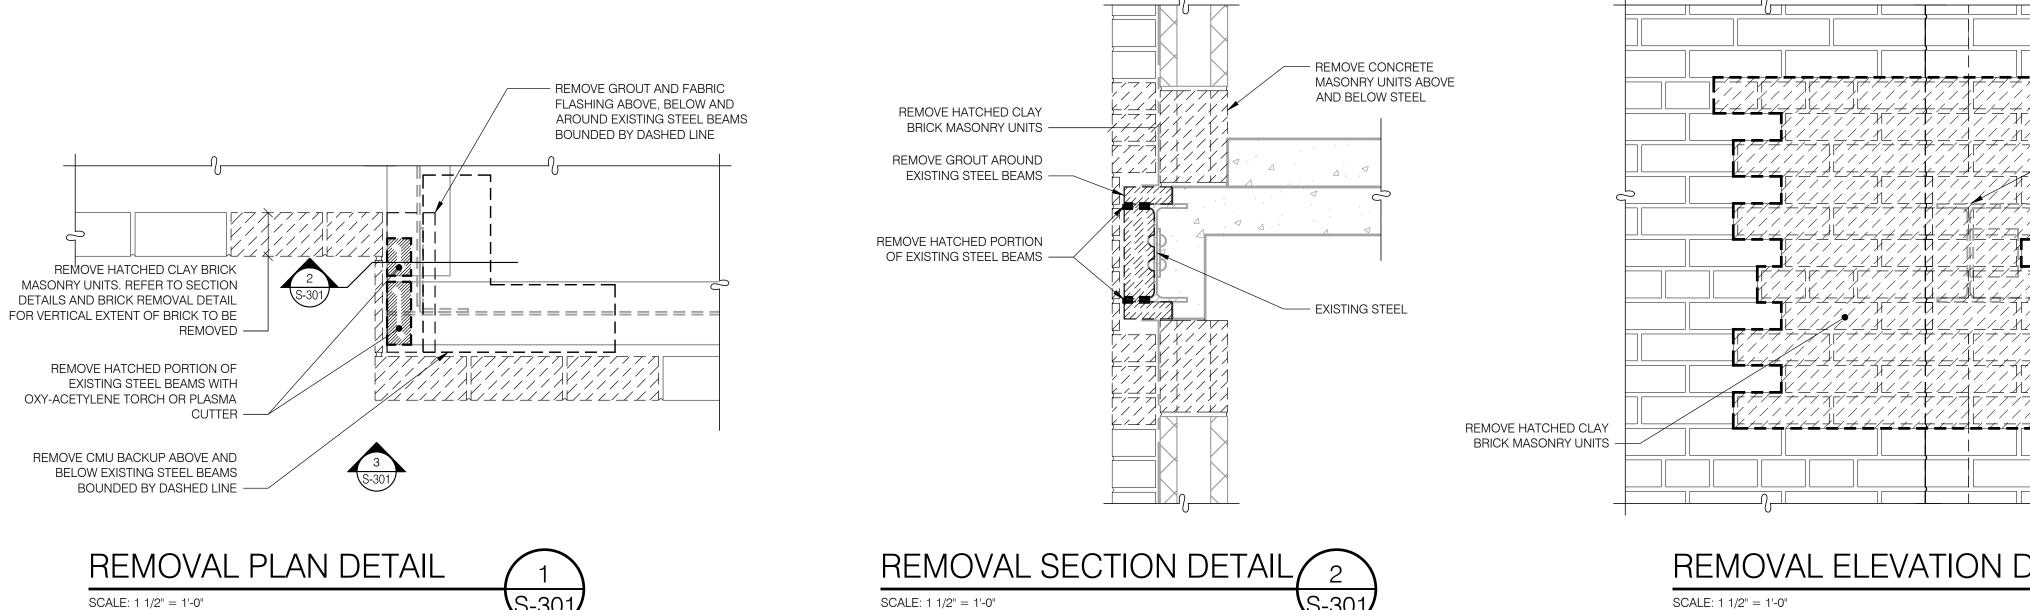
NEW CLAY BRICK MASONRY UNITS ----

. REMOVE CLAY BRICK MASONRY UNITS AS SHOWN TO ALLOW FOR ACCESS TO AND PARTIAL REMOVAL OF STEEL BEAMS.

4. REMOVE INDICATED PORTIONS OF EXISTING STEEL BEAMS WITH OXY-ACETYLENE TORCH OR PLASMA CUTTER.

5. PROVIDE GROUT SLOPED TO MATCH ADJACENT ON TOP OF ALTERED STEEL BEAMS.

REMOVE ONE CONCRETE MASONRY UNIT IN EACH DIRECTION (NORTH-SOUTH AND EAST-WEST) AT CORNER ABOVE AND BELOW STEEL BEAMS. 3. REMOVE SPANDREL FABRIC FLASHING AND SLOPED GROUT AROUND EXISTING STEEL BEAMS 2" BEYOND EXTENT OF EXISTING STEEL BEAMS

5. PROVIDE COLD FLUID APPLIED WATERPROOFING SYSTEM OVER GROUT AND AROUND EXPOSED STEEL. PROVIDE 4" LAP OVER EXISTING

B. PROVIDE REPLACEMENT CLAY BRICK MASONRY UNITS. PROVIDE PARTIAL WIDTH UNITS AT STEEL CONFLICT LOCATIONS ON EAST AND WEST

**REPAIR SEQUENCE:**

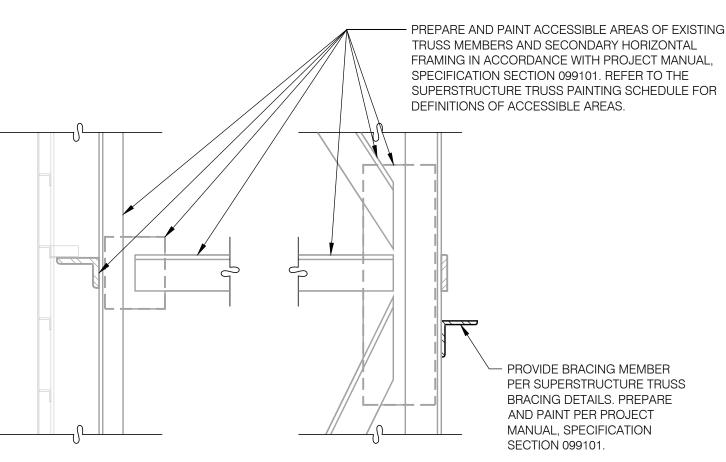
TYPICAL SUPERSTRUCTURE TRUSS PAINTING DETAIL

SCALE: 1 1/2" = 1'-0" NOTE: PAINT TO BE APPLIED FOLLOWING INSTALLATION OF REINFORCEMENT AND BRACING.

FRAMING IN ACCORDANCE WITH PROJECT MANUAL. REFER TO 10/S-306. ACCESSIBLE AREAS ARE DEFINED IN THE FOLLOWING NOTES. 3. "P1" INDICATES ENTIRE TRUSS AND ADJACENT SECONDARY HORIZONTAL FRAMING ARE

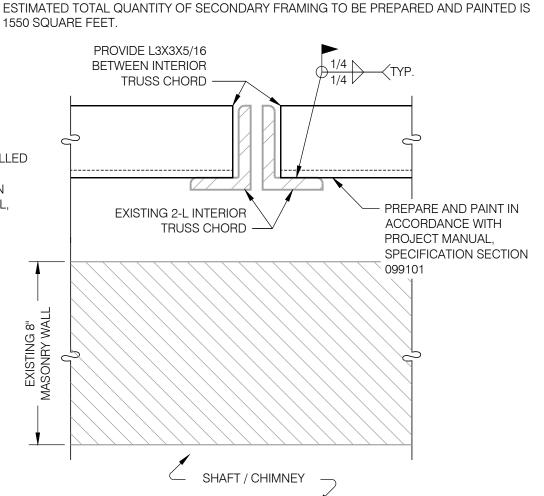
## SUPERSTRUCTURE TRUSS BRACING @ MASONRY WALL PLAN DETAIL

S-306 SCALE: 3" = 1'-0"

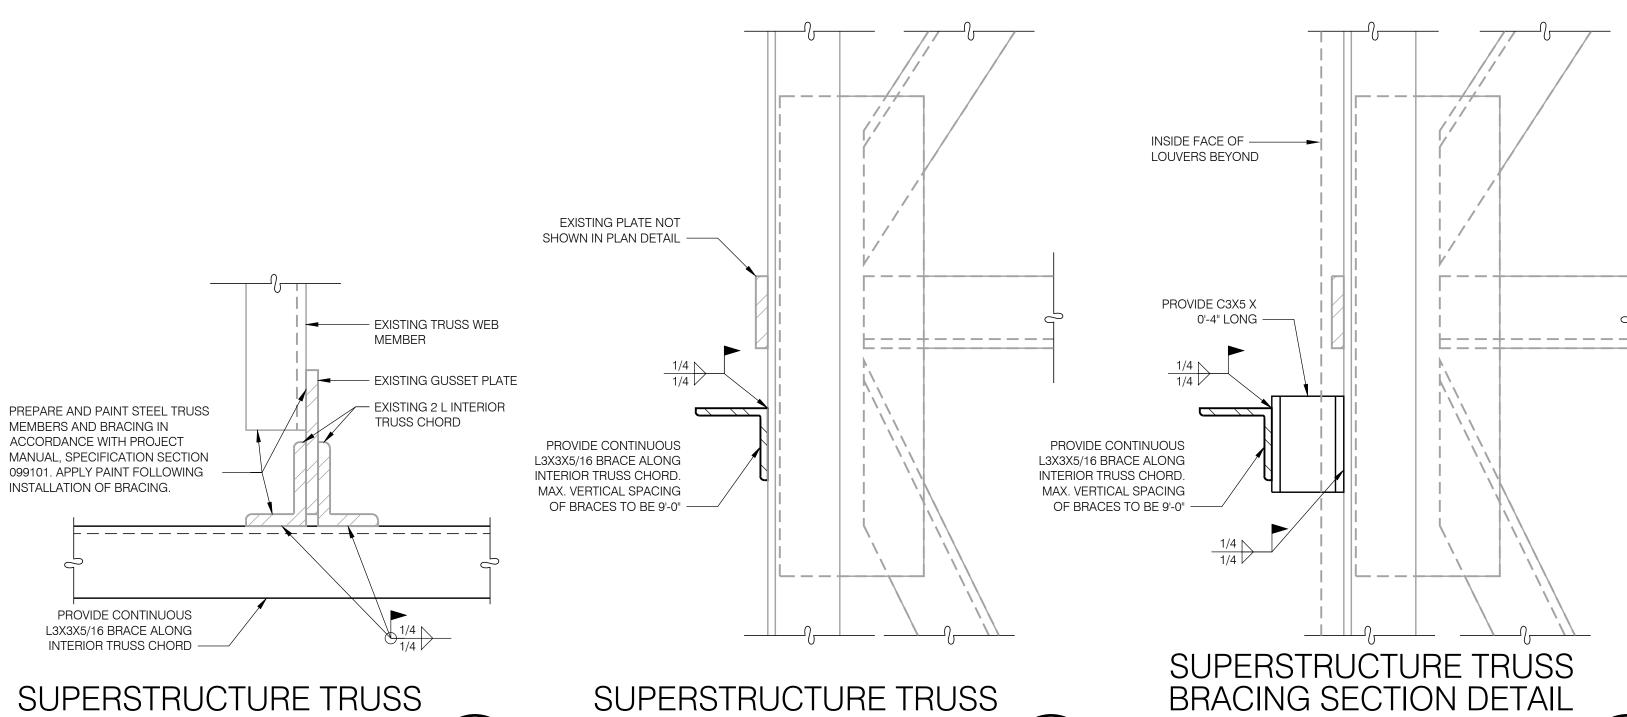
BRACING SECTION DETAIL

SCALE: 3" = 1'-0"
